**PROPERTY CONDITION  
ASSESSMENT REPORT**

Kmart Shopping Center  
118-124 Waller Mill Road  
Williamsburg, York County, Virginia 23185

April 24, 2019 (Revision 1)

PSI Project No. 0443-1046

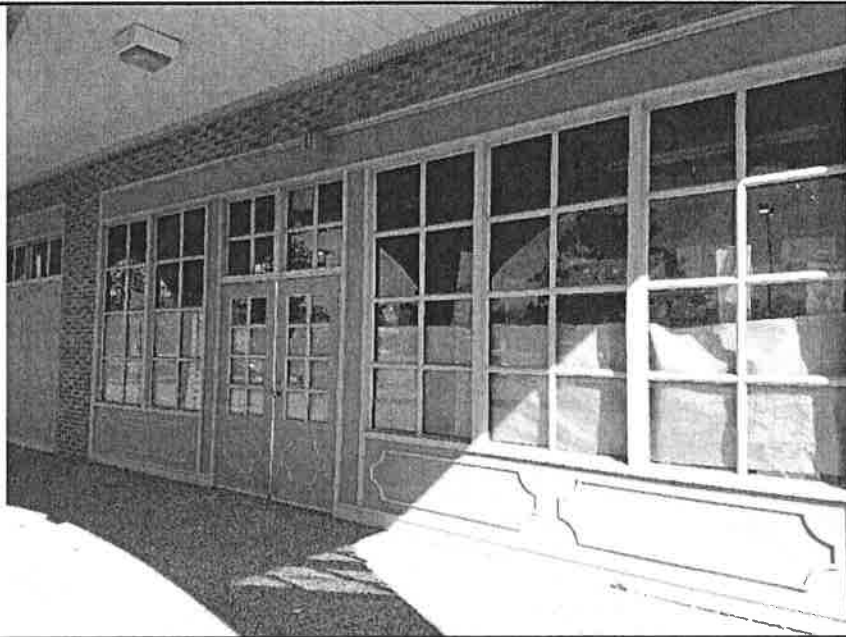
The exterior metal doors and windows of the Kmart space generally appear to be in good condition. The wood framing of the shop windows and doors are exhibiting rot and are recommended for replacement.

**Photo 7:** Typical wood windows and doorways at tenant small shop spaces.

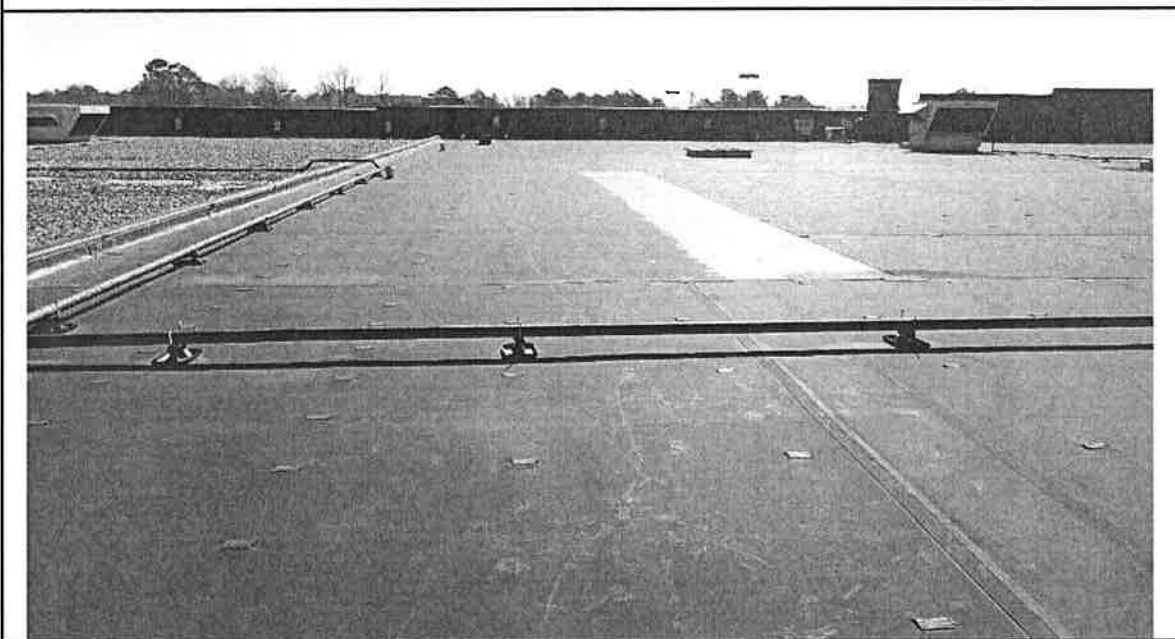
The Saturn type EPDM roofing over the Kmart appears to be in overall fair to poor condition. There were several of the Saturn type buttons securing the EPDM in place were observed to be missing and large repair areas to the EPDM were observed on the front roof area at the outdoor lawn and garden area. The Ballasted EPDM roof section is in poor condition. The stone ballast is displaced in numerous areas and previous repair areas were observed. PSI recommends replacement of this roof area.

**Photo 10:** Overview of Kmart roof.

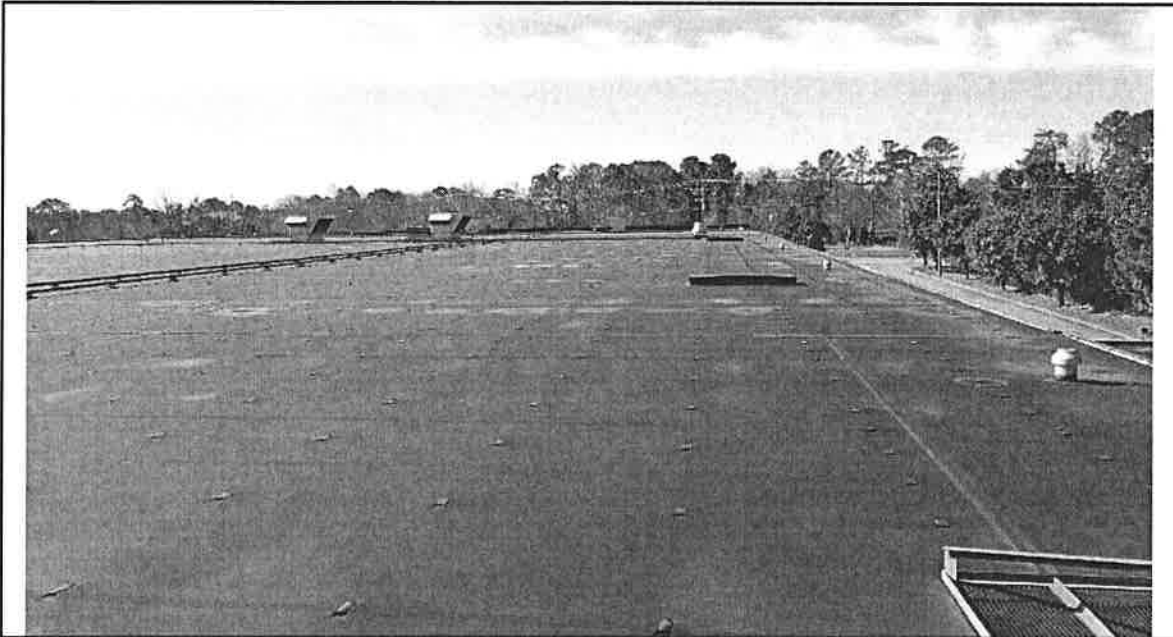
**Photo 11:** Overview of Kmart roof.

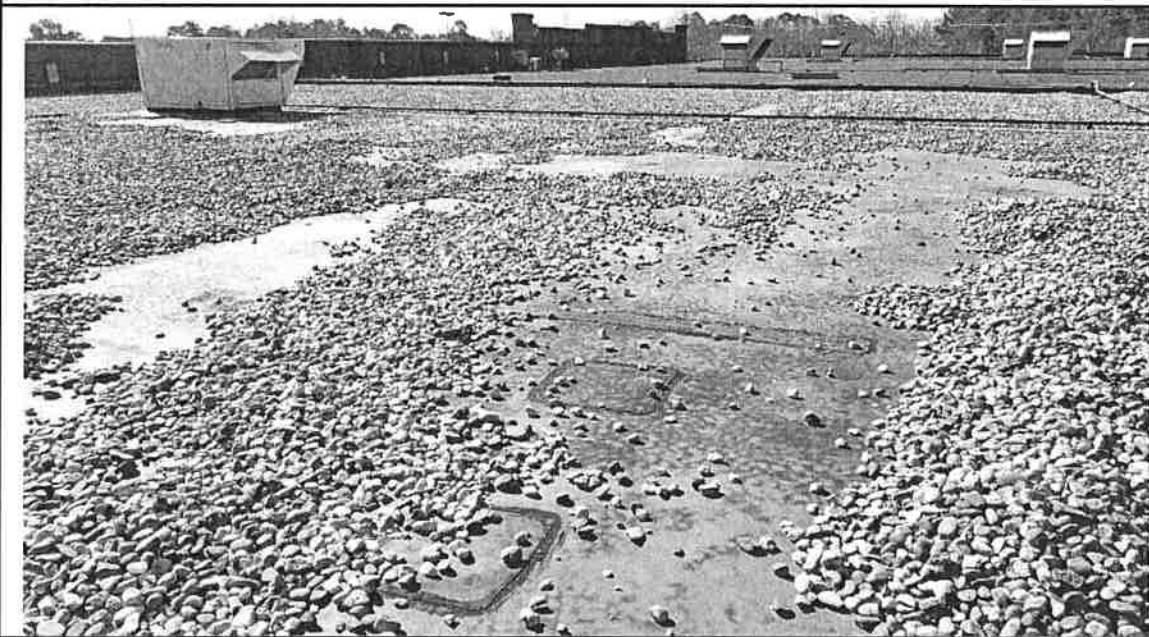
A portion of the Kmart roof consists of a ballasted EPDM roof system. The roofing membrane is approximately 20 years old according to a date stamp observed on the EPDM membrane. Concrete pavers are used to provide walking surface between roof top HVAC units. A raised gravel bar is installed along the gutter edge.

**Photo 12:** Displaced ballast along portion of Kmart roof.

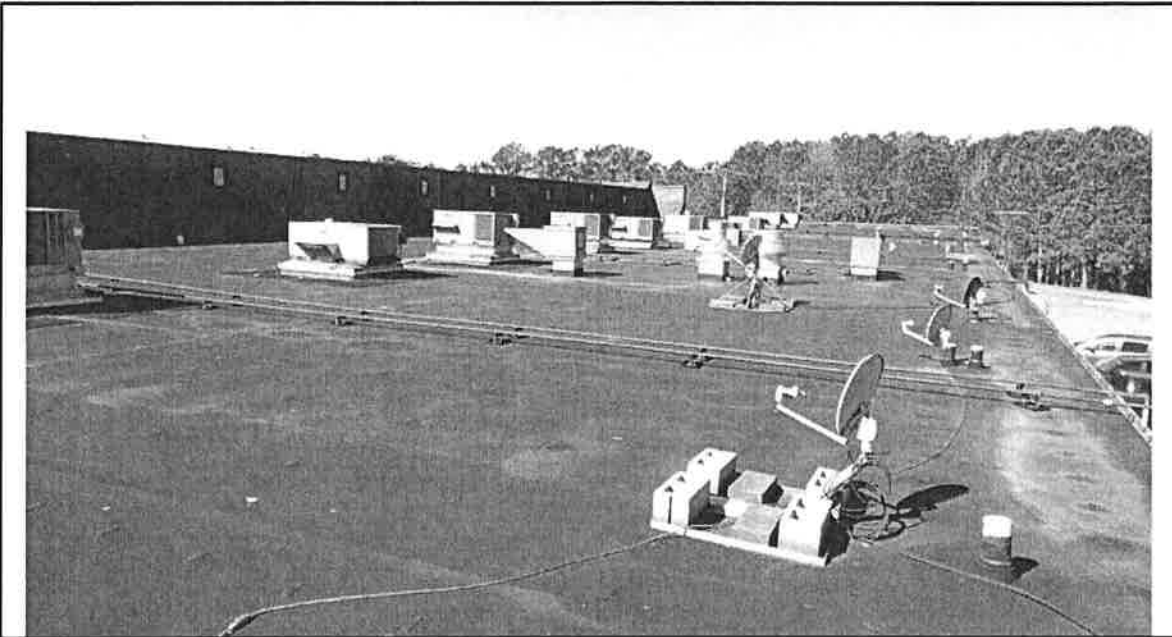
The roofing at the northeast section of the center is in overall poor condition. Numerous Saturn buttons were observed to be missing and several tears and failed flashings were observed. There were reportedly numerous leaks associated with this roof section. PSI recommends replacement of this roof area.

**Photo 15:** Overview of small shops roof.

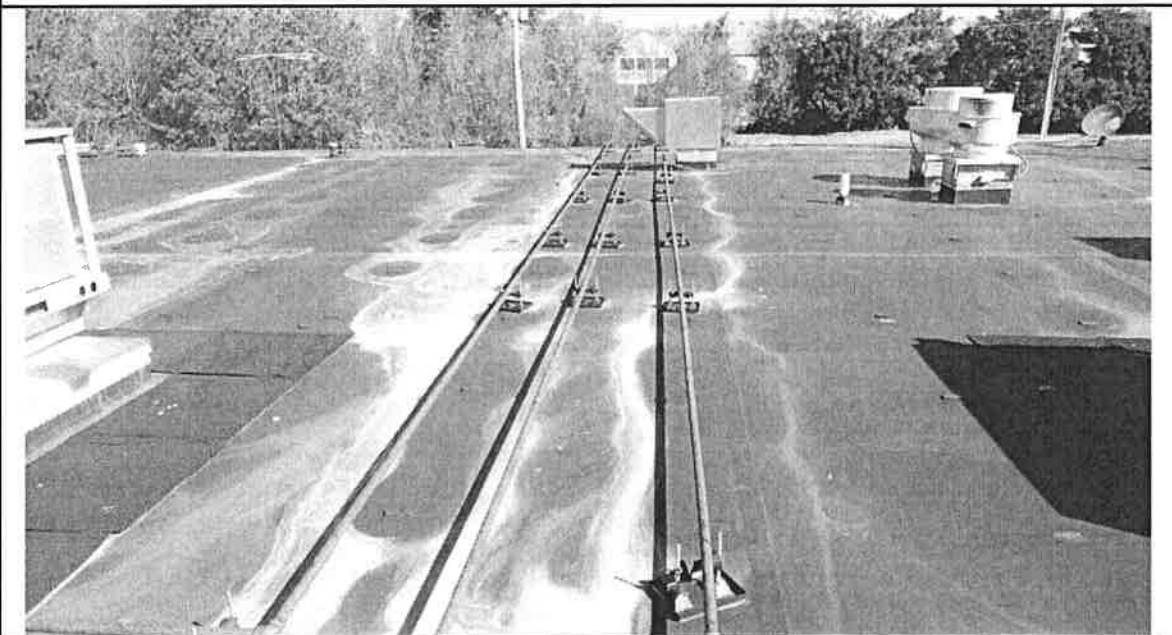
**Photo 16:** Overview of small shops roof.

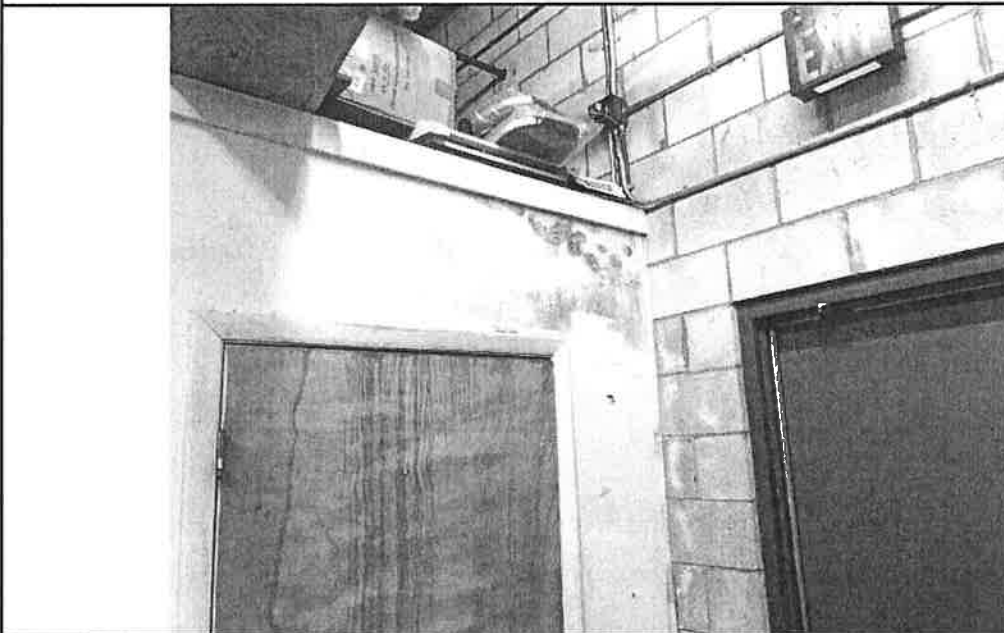
Photo 28: Example of staining, damage, and possible mold growth on interior finishes (photo provided by Client).
